## LAND CORNER RECORD

| Index: E-15 | Corner: 1/4 Corner between Sections 3 and 10 | State of Indiana - Hoosier National Forest |
| Section: 10 | Township: 7N Range: 1E P.M.: 2nd | County: Monroe |

## MONUMENT RECORD

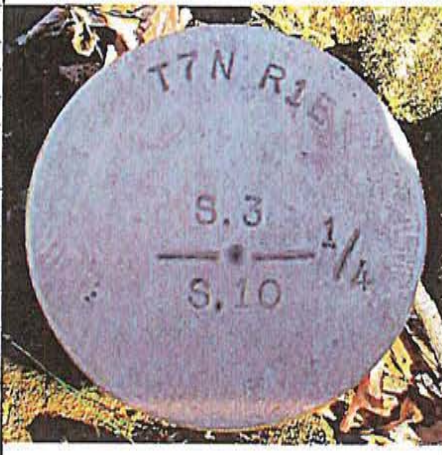
| 1.) Date of Survey: | Surveyor: | Monument: | Recording Information: | Monument Photograph: |

| 1.) Date of Survey: | Surveyor: | Monument: | Recording Information: | Monument Photograph: |
|---|---|---|---|---|
| 9/1984 | Ken Anderson<br>L.S. #80040545 | A stamped 3" aluminum monument found | USDA Forest Service<br>Bedford, IN | |
| Record evidence of prior survey: | Ken Anderson set this monument in 1983 on an unrecorded survey. | | | |

| Reference Objects: | Object or Tree Species: | Diameter: | Bearing: | Distance: |
|---|---|---|---|---|
| Monument Found or Set: | A 3" aluminum monument stamped "T7N R1E S.3 S.10 1/4" found 0.5' above grade. | | | |

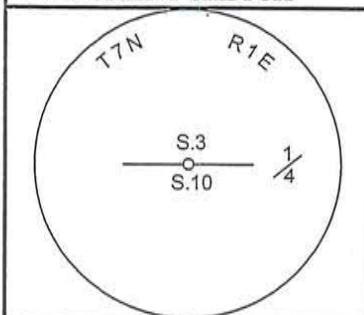
## MONUMENT SKETCH

Monument is a 3" aluminum monument stamped "T7N R1E S.3 S.10 1/4" found 0.5' above grade, a carsonite post is located 3.0' west of the monument, located on a steep westerly facing slope, +/- 50' west of a drive, +/- 30' east of a north-south running drainage, surrounded by mature hardwoods, 51' north of a culvert with limestone scattered all around, a rock cairn at the base of the monument.

The record monument was found undisturbed and maintained by remarking two existing bearing trees and establishing two new reference objects. Two existing bearing trees were recovered from Monument Record by Michael Friley, dated 5/9/1995.

Two bearing trees were marked with a bearing tree sign, paint, and mag nail.

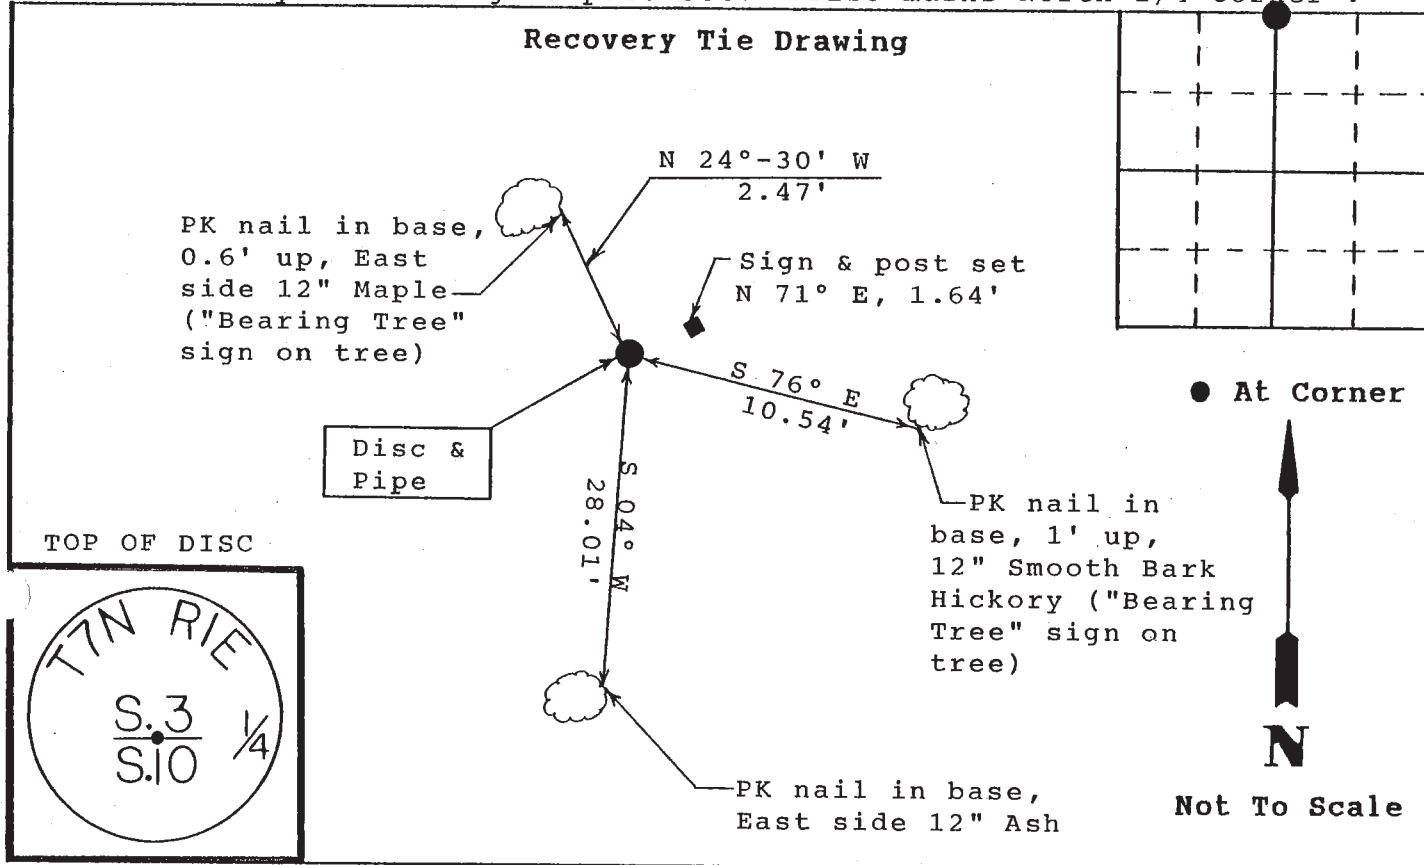
Recovery Tie Drawing

Monument Description & Remarks: Found 3" Aluminum Disc on 2" Aluminum Pipe;  
0.6' out of ground. Pipe was solid in ground, cairn of rocks placed around  
base. Survey marker sign & post set. Disc marks North 1/4 Corner.

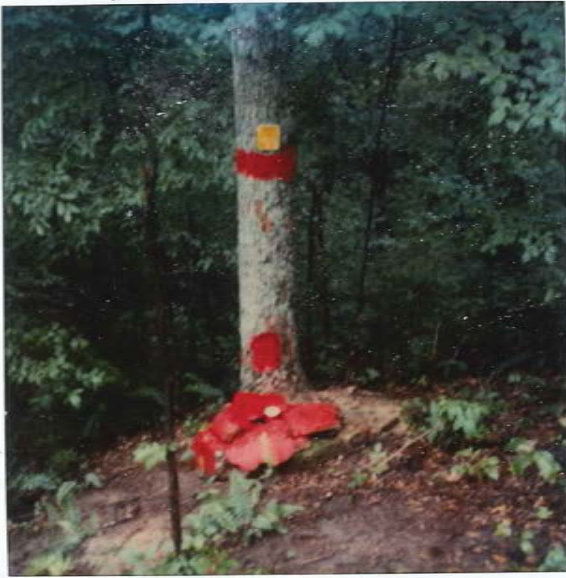
1/4 corner sec's 3 & 10  
T7N R1E 6/30/83

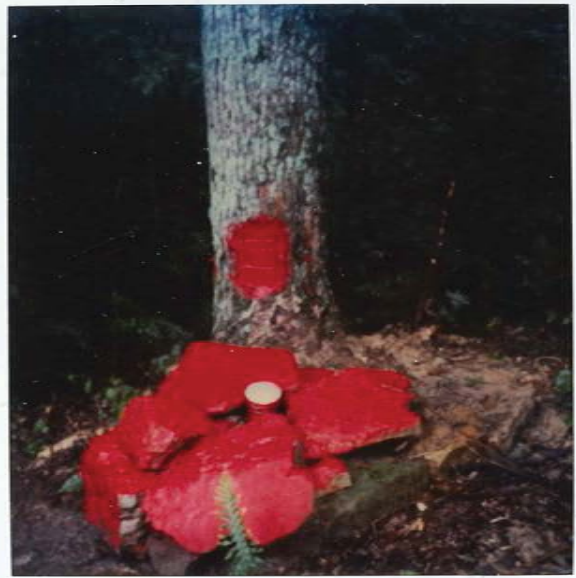
1/4 corner sec's 3 & 10  
T7N R1E 6/30/83  
B.S.
